FALLING WEIGHT TESTS ON ROCK FALL GALLERIES WITH CUSHION LAYERS

Kristian Schellenberg¹, Axel Volkwein², Matthias Denk³, Thomas Vogel¹

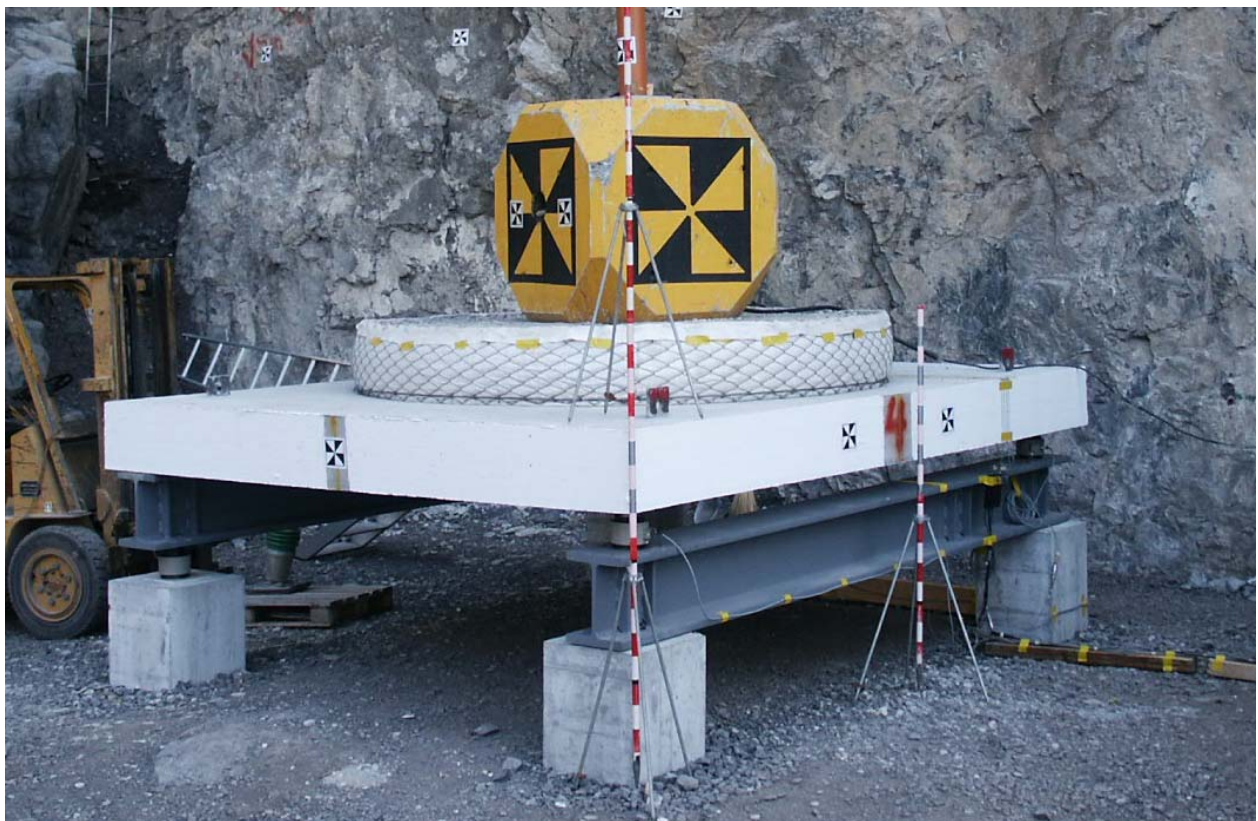
Figure 1: Test setup with gravel cushion and 4000 kg boulder

The slab's dimensions of 3.5 x 4.5 m correspond to an average rock fall protection gallery in a scale of 1:2. They were line supported along one side and pile supported on the remaining two corners (see Figure 1). The slabs are covered by a conventional or by a special cushion system consisting of high-tensile steel wire mesh filled with a layer of light-weight cellular glass (Misapor). Two instrumented boulders of 800 and 4000 kg were used as falling weights to
