Experiments with sediment replenishment in a residual flow reach: Comparison of field data with laboratory experiments

Severin Stähly^{1,*}, Anthony Maître¹, Mário J. Franca^{1,2}, Christopher T. Robinson³,
and Anton J. Schleiss¹

¹Laboratory of Hydraulic Constructions (LCH), Swiss Federal Institute of Technology Lausanne (EPFL), Switzerland

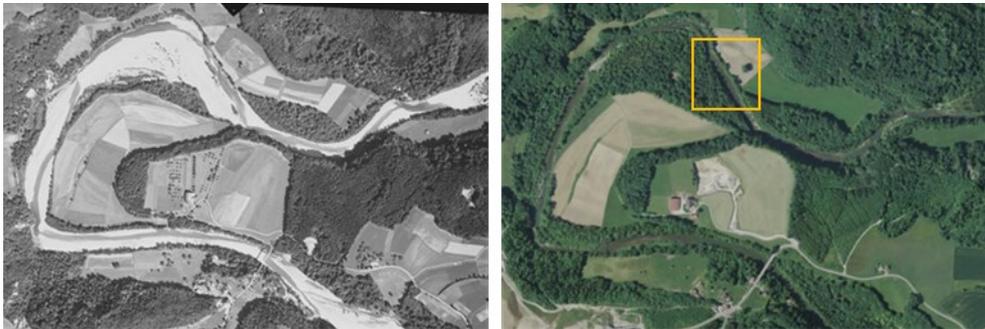
Fig. 1. Comparison of a meander at the Sarine residual flow section from 1943 (left) and 2012 (right). The active floodplain from 1943 almost disappeared. Nowadays, hardwood forest is present and the dynamic behavior of the river is strongly reduced. The yellow square corresponds to the location where the sediment replenishment was added (Fig. 2).

Laboratory experiments pointed out that for steep rivers with a longitudinal slope of 1.5%, a combination of four deposits assembled as alternate bars result in a favorable deposition process [6, 7]. Such a cluster formation in the river creates habitats that are valuable for fishes. Especially in bedrock-alluvial rivers such as the Sarine with exposed molasse rock, a deposition in clusters is more valuable for in-stream organisms than a homogenous uniform distribution in the river. As can be seen in Figure 2, deposit I and III are located touching the left bank, at a distance corresponding to one deposit length L . Attached to the right bank, deposit II and IV have been arranged longitudinally shifted by half a deposit length (Fig. 2). The extent of Figure 2 corresponds to the yellow square in Figure 1. Unlike in the laboratory

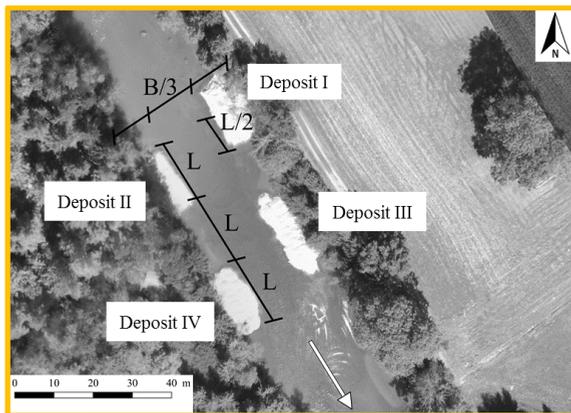
Fig. 2. The four deposits of sediment replenishment in the Sarine river. The distance between deposit I and deposit III as well as between deposit II and deposit IV was one deposit length L . Deposit I and deposit II are shifted by half a deposit length $L/2$. The deposits should occupy two thirds of the river width B . A larger overview of this reach can be seen in Figure 1.

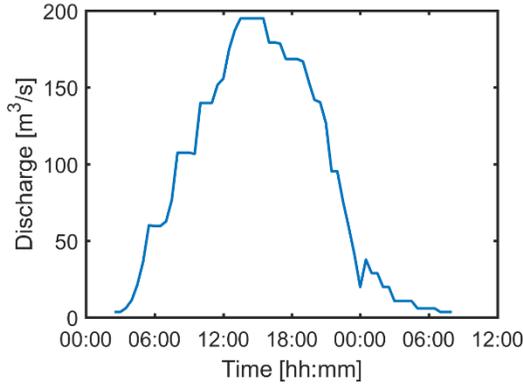
Fig. 3. The hydrograph of the artificially-triggered flood in September 2016. The peak discharge of $195 \text{ m}^3/\text{s}$ was released during two hours. The steps in the increasing limb of the hydrograph were operated with intention to calibrate gauging stations and to detect the critical discharge for sediment movement.

In September 2016, an artificially-triggered flood was released from Rossens dam with a peak discharge of $195 \text{ m}^3/\text{s}$ during two hours (Fig. 3). The steps on the rising limb of the hydrograph served as a calibration for gauging stations and to validate the critical discharge for sediment transport. Initially, a larger flood with a peak discharge of $255 \text{ m}^3/\text{s}$ was planned, but due to an error in the rating curves of spillway gates at Rossens dam, only a maximum discharge of $195 \text{ m}^3/\text{s}$ was reached. Thus, resulting in a significantly less powerful flood than expected. As mentioned, the hydrograph was designed by engineers to clean the river from algae and mobilize the armor layer of sediment, it was not designed after the laboratory experiments. $255 \text{ m}^3/\text{s}$ was the limit for the peak discharge, because a higher discharge may have flooded a landfill site. Therefore, the discharge was designed to stay above the threshold for particle movement for a longer time than it is the case in a natural flood with the same

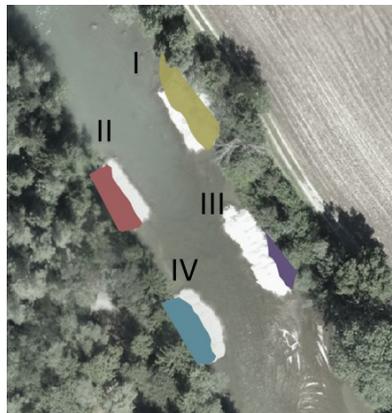
Fig. 4. The four deposits before (background image) and after (colored areas) the flood event. Deposit I and IV were half eroded, deposit II changed only a little and deposit III was mainly transported away.

The deposits in the Sarine were only partially eroded. Deposit I and deposit IV were about half eroded, deposit II was very little eroded and deposit III only a small portion was left. In Figure 4, the outline of the deposits after the event are displayed on an air image from before the flood event. The evolution of deposit I towards the upstream indicates deposition from upstream sediment.

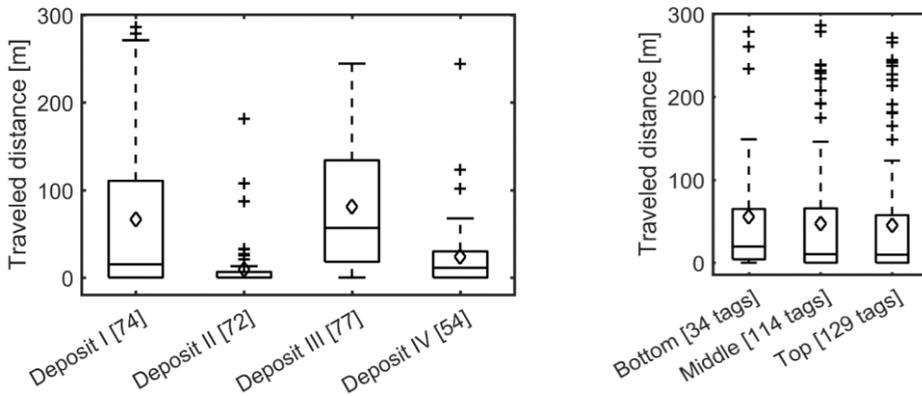
Fig. 5. Transport distances of the RFID PIT tag equipped stones in the Sarine river. The left figure corresponds to the deposit of origin, the right figure to the location in the deposit.

As mentioned, the artificial flood in the Sarine river did not fully erode the deposits. With the low peak discharge, the submergence of the deposits was minimal and mainly lateral erosion took place. This fact is supported by Figure 5 indicating that tagged stones installed in the top, middle and bottom move the same distance. With the initially planned discharge, the submergence of the deposits would have been significantly higher. Thus, the shear stress on the top layer would have been larger and the stones from the top layer would have been further transported in average than the stones from the bottom layer.

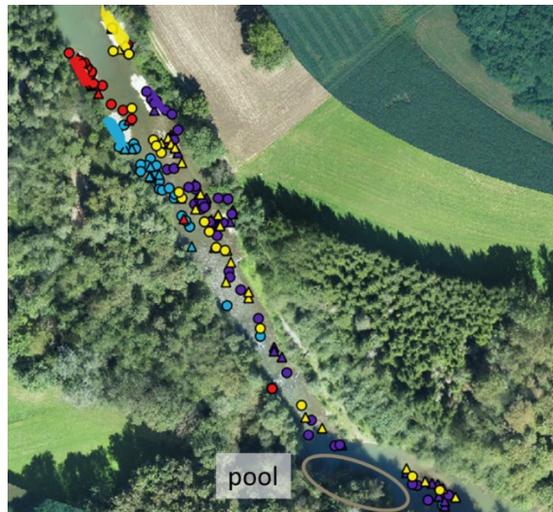
Fig. 6. Distribution of the RFID PIT tag equipped stones in the Sarine river. The color indicates the origin of the stones from the initial deposit. There is a pool in the bend downstream. D_{90} are indicated with a circle, d_m with a triangle.

The distribution of the tagged pebbles in the river revealed clusters. A first deposition cluster can be observed at a distance of about one river width downstream of deposit IV. There, especially pebbles from deposit I and IV were found. Another river width further downstream, a second deposition cluster is present. There, mainly cobbles from deposit I and III were found. Transversal dispersion of the pebbles, meaning that pebbles from a deposit from the left river bank were found in the right part of the river and vice-versa, was not observed. After this second cluster, there were some single pebbles but not a cluster until the pool. Downstream of the pool, another sediment deposition cluster can be detected with mainly pebbles from deposit III and I. One single pebble of deposit IV was also found. As already calculated in Table I, Figure 6 shows that the pebbles from deposit I and III travelled on average further than pebbles from deposit II and IV.

In the current case, the results need to be compared with an intermediate state of the laboratory results (see Fig. 7, [6]). The results from time step $t = 60$ min corresponds with the observation from in the Sarine. Deposit III is almost fully eroded, deposit I almost untouched, deposit II and IV show an erosion pattern that is also observed in Figure 6. The difference in deposit I may come from the fact that the replenishment is located just downstream of a mild river bend (Fig. 1) that induces secondary currents, and the stress on deposit I is higher than in a straight channel. Concerning the deposition of the replenishment, there is one large cluster forming in the channel in a distance corresponding to three channel widths downstream of deposit IV. This can also be observed in the field experiment, in a distance one and two river widths downstream of deposit IV. Analysing the morphology in the Sarine, these two clusters are located upstream of a relatively long riffle. In this riffle, large boulders are present and smaller pebbles either pass this reach or settle in front of it. A few of the equipped pebbles got stuck in these large boulders, as seen in Figure 6.

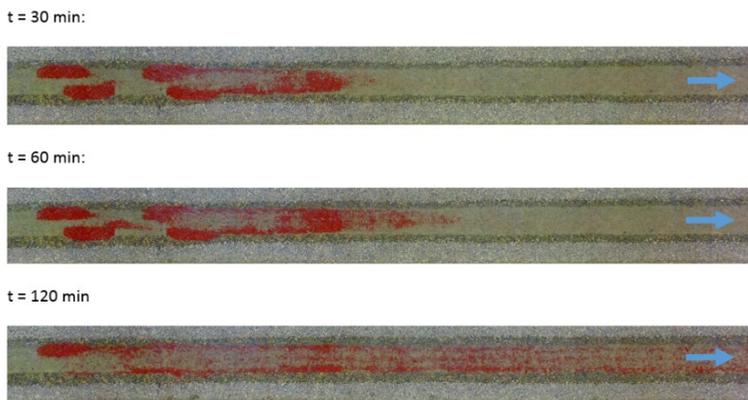
Fig. 7. Laboratory experiment with replenishment in a trapezoidal channel. The situation after the flood event in the Sarine corresponds mainly to the state after $t = 60$ min [6].
