# Experience with Testing and Performance Evaluation of Bituminous Plug Expansion Joints on Concrete Road Bridges

**Abstract.** This paper contains a short state of the art overview on bituminous plug joints (BEJ) in Switzerland. Such BEJs are of particular interest because of their noise reduction properties. BEJs designed for joint movements up to 100mm were investigated in the lab and field as a basis for guidelines by the Swiss Federal Road Office. Special test procedures including gel permeation chromatography (GPC), testing of adhesion between joint filling material and adjacent pavement, rutting performance testing with model mobile load simulator MMLS3 as well as cold temperature movement capacity testing with a joint movement simulator are presented. In addition, long-term field performance of standard BEJs for small joint movements and special wide BEJs, some of them containing moving aids for large joint movements, are discussed. It was found that the tools and requirements elaborated in the Swiss guidelines are suited to reduce the risk of BEJ failure. It became also apparent that placing technology and climate play a significant role in achieving well performing BEJ f

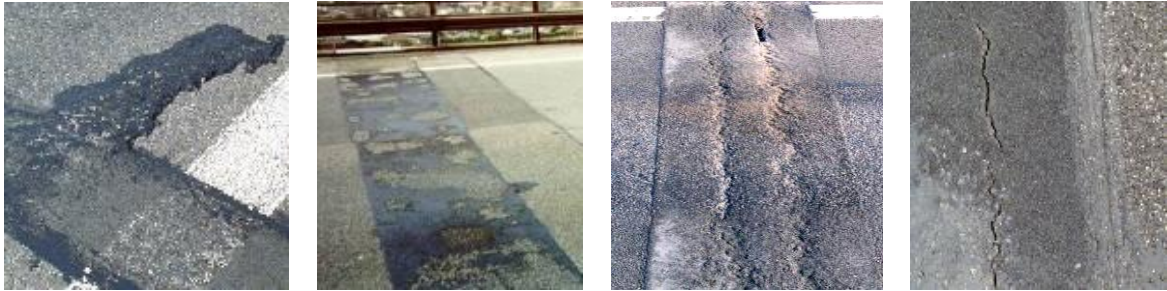
Figure 1. Damage of BEJ (from left to right): material transport. & displacement & run out in summer; aggregate loss & surplus of binder; cohesion cracks & adhesion cracks along BEJ site in winter; cracks from too large BEJ movement  $> 30$  mm

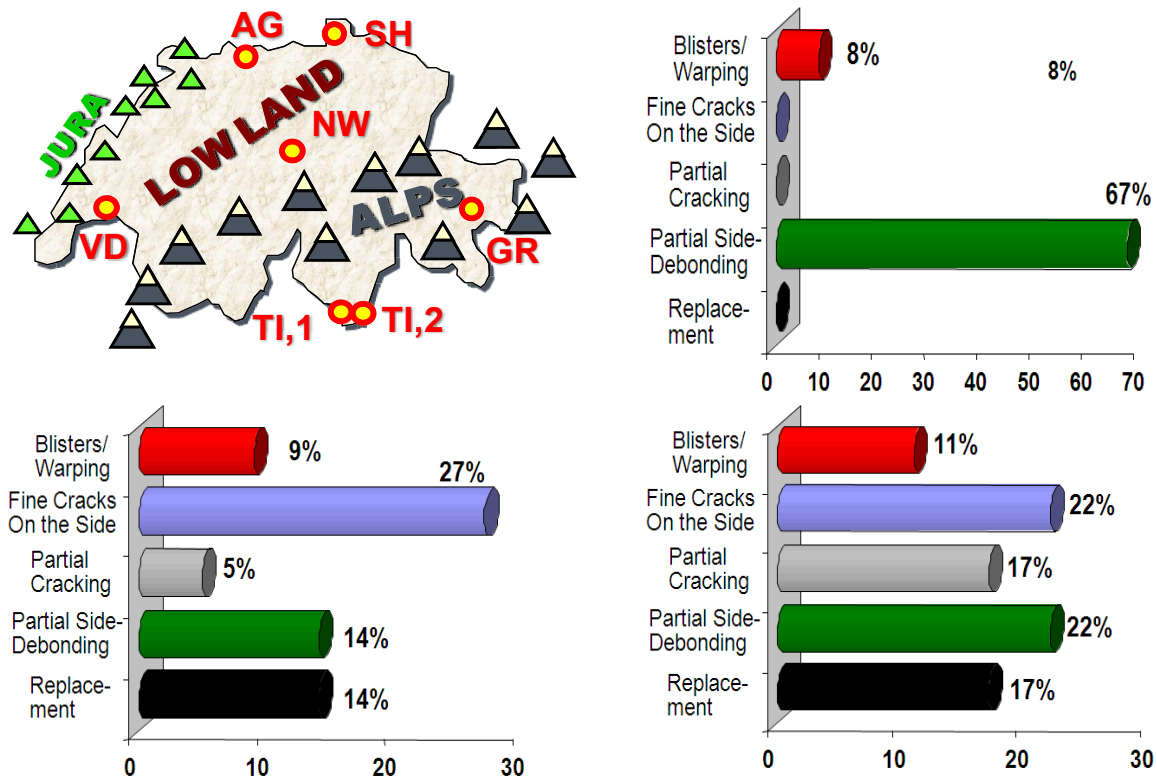
Figure 8. Locations of the BEJs (top left) and results of the damage assessment of the expert group at parapet (top right), in the border zone & emergency (bottom left) lane and in traffic lane (bottom right)

The plug joints were located on a series of 80 m span slope-side bridges of the A2 motorway in the Mediterranean southern part of Switzerland (TI,2 in Fig. 8) with a traffic volume in each direction of 30'000 vehicles per day. The width of these plug joints ranged between 750 mm to 1'370 mm, thus considerably exceeding the standard width of 500 mm specified by Swiss guidelines [7]. The horizontal design movement was between 8 to 48 mm as indicated in Figure 11.

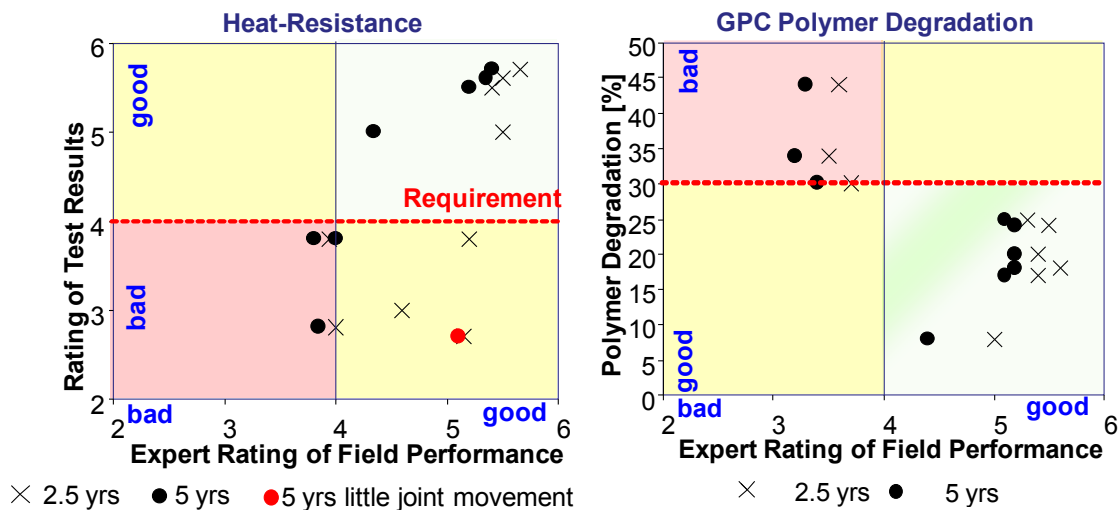
Figure 9 shows the change of rating and properties over the years for the BEJs in dense pavements with respect to heat resistance in the lab tests and gel permeation chromatography (GPC) measurements of polymer degradation in the field. Polymer degradation with GPC is defined here as the ratio between the UV signal peak of the original and the degraded polymer (see Fig. 10). Also shown are the dashed lines of requirement, dividing the zones with bad and good behavior. The agreement between lab and expert assessment is particularly satisfying in case of GPC polymer degradation. One specimen (TI,1 in Fig. 8) showed good expert rating of performance after 5 yrs and moderate polymer degradation in the field (red point), but bad rating in terms of heat resistance of the BEJ binder. This was probably due to the negligible loading from the little joint movements of this bridge which may have compensated for the unfavourable heat resistance properties in practice.

Figure 9. Lab results for heat resistance (left) and GPC polymer degradation (right) as compared to the expert assessment over a time period of five years

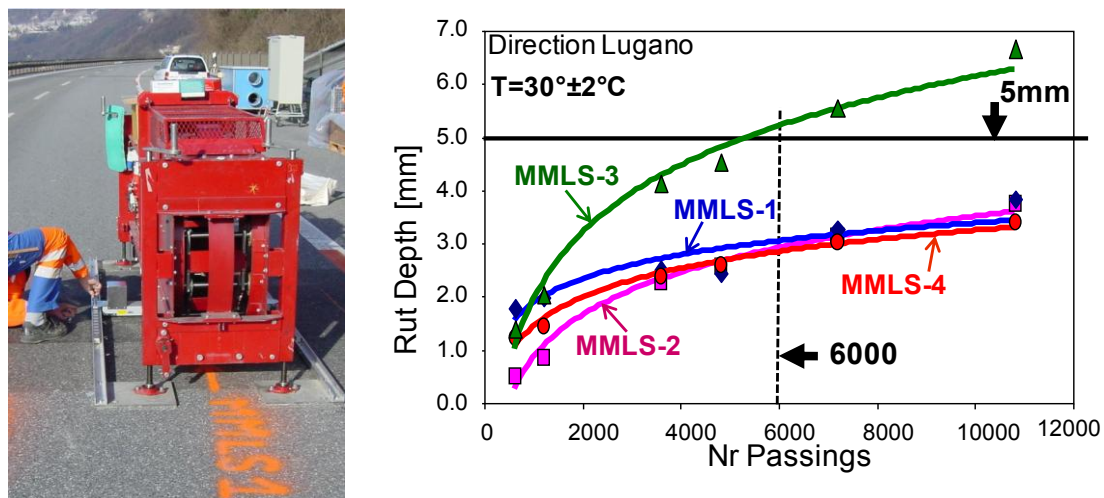
On-site investigations of the remaining rutting resistance of the plug joints within and between the wheel paths were conducted using the MMLS3 as indicated in Figure 11. MMLS3 testing was performed in a tent at 30 °C measured 20 mm below BEJ surface. This temperature condition was produced with a pair of heating fans. The experimental setup and the results are shown in Figure 12.

Except for the testing between wheel track at the testing site “MMLS-3”, with partly replacement of the BEJ top, all rut depths after 6'000 passings at 30 °C remained clearly below 5 mm, i.e. in the order of 3 mm. From this result one can conclude that partial renewal of the BEJ surface material can only be considered as a temporary solution and should be evaluated very carefully.

Figure 12. MMLS3 Setup before installing tent and heating fan (left) and rutting results on the northbound MMLS3 testing sites

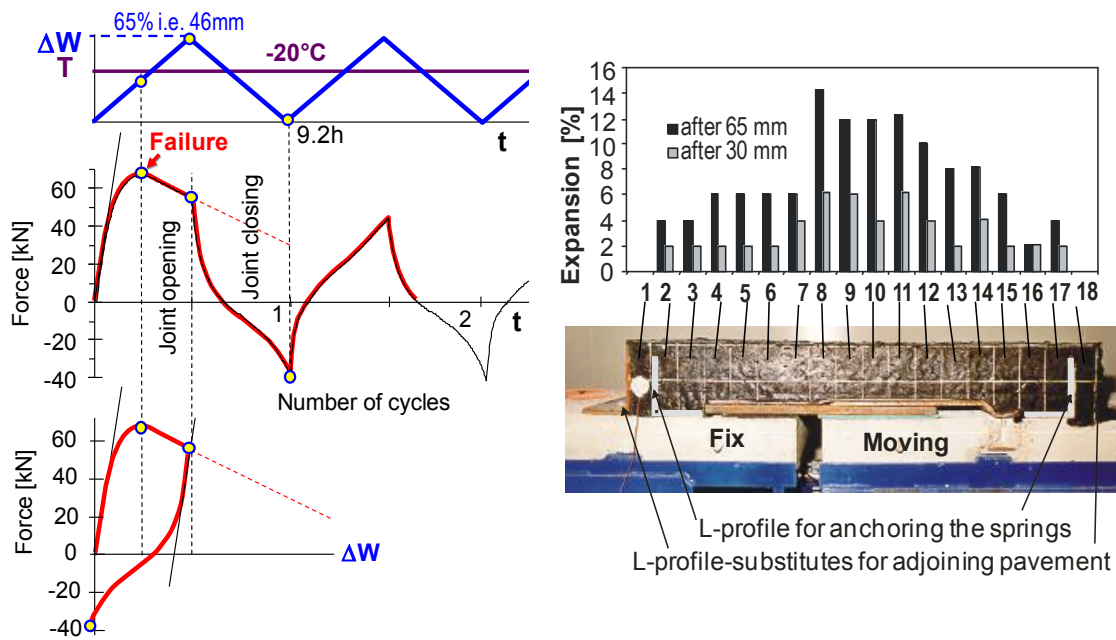
Figure 14. Test results of S7 at -20 °C and 9.2 h/cycle (left); horizontal expansion in S9 at joint openings after 30 mm and 65 mm at -20 °C (right).

The maximum force for S9 and S7 at -20 °C was approx. 80 kN and 60 kN respectively. After the first cycle, the force decreased by about 20% to 30% (Fig. 14) showing clearly that the maximum loading capacity during gap opening has been reached before the gap closing movement was activated. This gap closing movement started at the inflection point. During the gap opening of the next cycle, the load could not exceed the load value in this inflection point, of course. Reaching the maximum loading capacity during the first cycle is a clear indication that significant damage in the BEJ occurred.

During joint opening of S9 up to 65 mm at  $-20^{\circ}\text{C}$ , strains between the adjoining asphalt pavement and the L-shaped steel anchors of the springs remained minimal and most deformations were distributed in the zone between the two L-shaped steel anchors. The part of the asphaltic plug joint above the sliding steel plate suffered the most significant local expansion (Fig. 14). In JMS tests, S9 showed significant lateral contraction of about 16 mm and a thickness reduction of 7 mm.

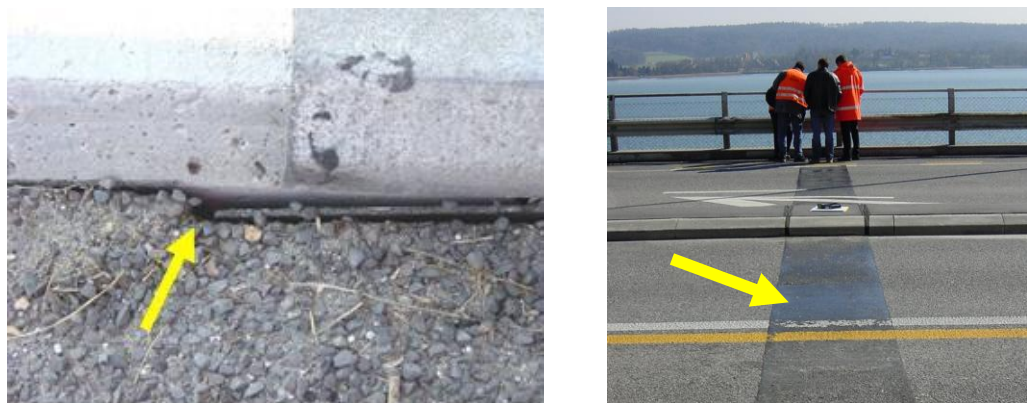
Investigations of the in-situ performance of S9 and S7 BEJs on bridges after about 1÷6 years took place together with different experts, comprising visual assessment of cracking in the asphaltic joint filling material, lateral debonding, debonding between joint and pavement, blistering, material dislocation, local deepening of the surface, water tightness, etc. (Fig. 15).

Figure 15. Edge debonding between asphaltic joint filling material and lateral metal plate (left); accumulation of binder at the surface edging.
