Long term behavior of epoxy adhesives and FRP's for strengthening of concrete

Christoph Czaderski¹, and Urs Meier¹

¹ Empa, Materials Science and Technology, Dübendorf, Switzerland

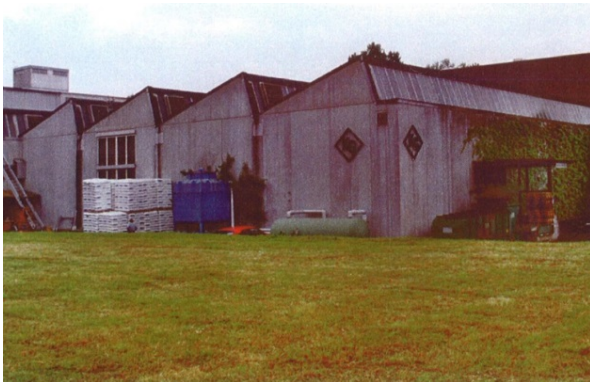
Figure 1: Industrial building in Kreuzlingen in Switzerland, which was strengthened in 1970 by means of steel plates.

Prefabricated reinforced concrete (RC) elements of the roof of an industrial building (Figure 1) had to be strengthened in 1970. The reason for the strengthening was that cracks were observed and it was found that insufficient internal steel reinforcement existed in the prefabricated RC elements. It was decided, that the RC elements shall be strengthened with externally bonded steel plates. Figure 2 shows the strengthened industrial building on a photo in the year 1992. The steel plates are indicated with red arrows. They are hardly visible because of the white paint.

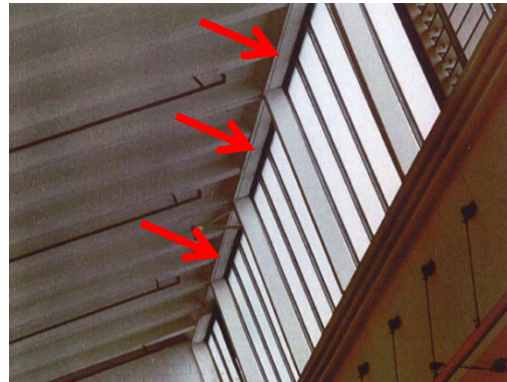
Figure 2: Detail of the inside of the building. The red arrows indicate the location of the steel plates. Photo was taken in the year 1992.

The beam is loaded as a four-point bending test (Figure 3 and Figure 4) and constantly loaded with 2×30 kN with lead weights. The beam is an edge beam as visible in Figure 2, what explains the nose cross beams visible in Figure 3. The constant load of 2×30 kN corresponds to 87% of the mean value of the failure load of the two static tests (Figure 5). This can be considered as a very high value near to failure. A photo of the failure mode during the static loading test of one of the beams is given in Figure 6.

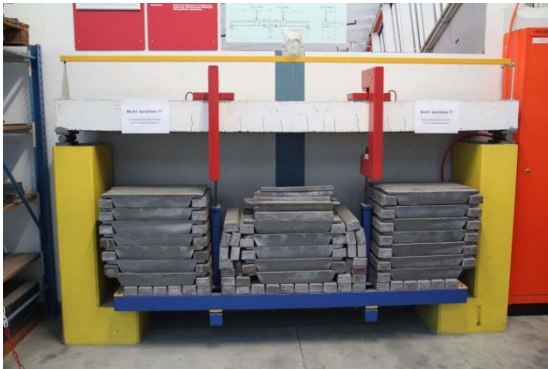
Figure 4: Long-term test at Empa: RC beam strengthened with a bonded steel plate under a sustained load.

The mid-span displacement of the long-term test is measured with a dial gauge (Figure 4) and the strains with a mechanical strain gauge. In the year 1986, the test had to be relocated in the laboratory and at this occasion, the loading with concrete blocks was changed to lead weights.

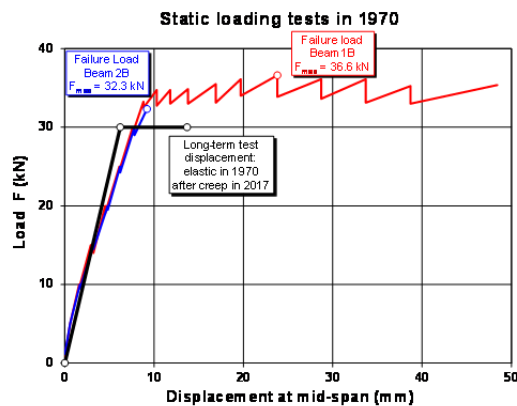
Figure 5: Load-displacement diagram of the static loading tests.

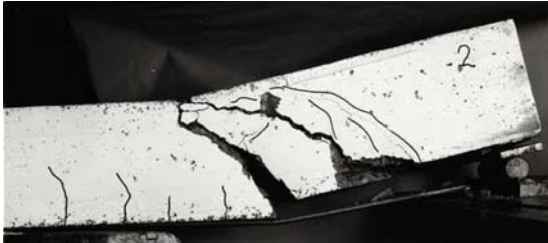
Figure 6: Failure mode in the static loading test on Beam 2B. Photo from the year 1970.

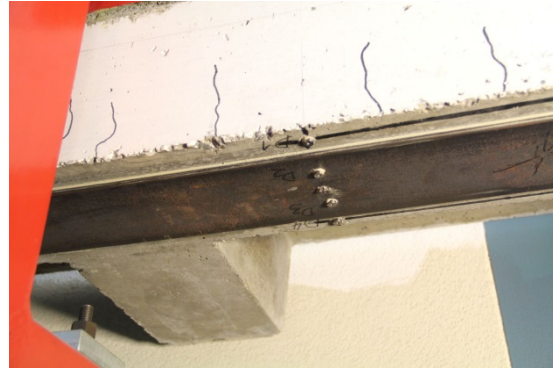
Figure 7: Bottom side of the beam in the year 2015. Surface corrosion is visible on the steel plate.

After 47 years, the beam is still in a good condition. The steel plate has some corrosion at the surface, what is considered as not relevant (Figure 7). The strain-time and displacement-time

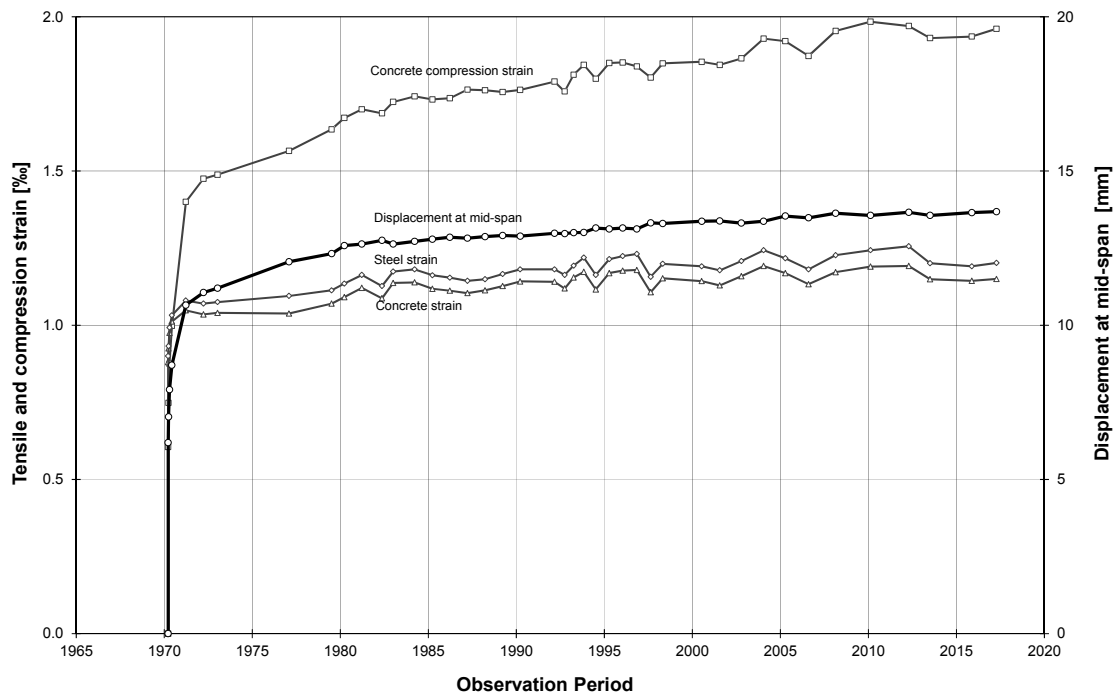
Figure 8: Long-term measurements since 1970 on the RC beam strengthened with an epoxy bonded steel plate.

diagram is given in Figure 8. It shows that the main creep occurs in the concrete in the compression zone. The corresponding creep factors (calculated by the ratio of displacement or strain at 11.4.2017 to 24.3.1970) are given in Table 1. It can be concluded that almost no creep takes place in the epoxy adhesive.

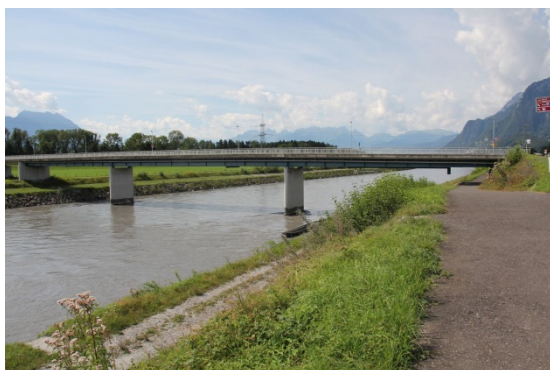
Figure 9: Bridge over the river Rhine near Oberriet in Switzerland.

Empa researchers developed the idea of using CFRP's instead of steel already in the 1980's, see Meier (1987) and Meier (1991). As already mentioned above, the Ibachbridge near Lucerne in Switzerland was successfully strengthened with CFRP strips in 1991 as a world premiere. These CFRP strips have up to now only once, in September 2008, been monitored due to very difficult access. The results, with a similar monitoring system as described in the following section, were fully satisfactory. The Rhine Bridge, built in the year 1963, connects Oberriet in Switzerland and Meiningen in Austria and crosses the Rhine River with three continuous spans (Figure 9). The steel-concrete composite superstructure comprises two steel girders and a cast-in-place concrete deck (Figure 10). The owner of the bridge is the Canton St. Gallen and the Land Vorarlberg.

The strengthening project in 1996 was necessary because of higher road loads and chloride contaminated concrete. On top of the concrete slab, a concrete layer was replaced and a new steel reinforcement for the negative bending moment in bridge cross direction was embedded. On the bottom of the slab, CFRP strips from the company Sika with a cross-section of 80 x 1.2 mm and a length of 4.2 m were applied in order to strengthen the positive bending moment in

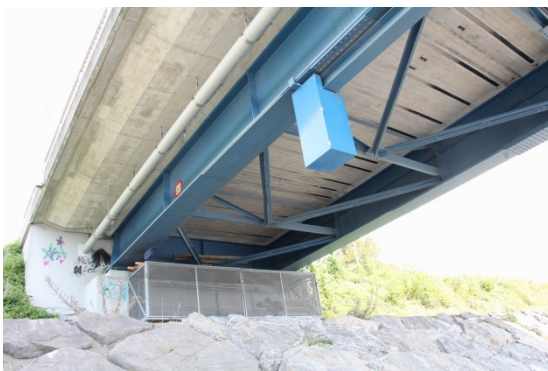
Figure 11: Underside of the bridge. The CFRP strips for the strengthening of the cross-direction are visible between the steel girders.

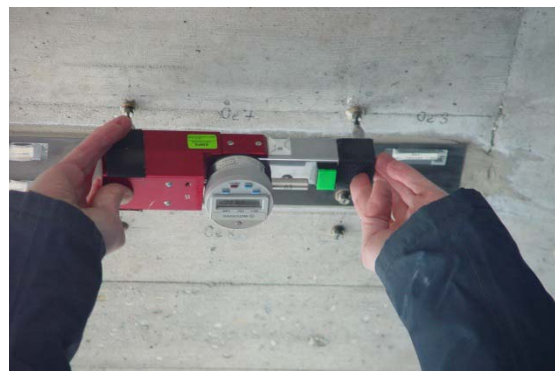
Figure 12: Mechanical strain gauge, which is used for the measurements.

Displacement measurements with a mechanical strain gauge on two of the CFRP strips and the adjacent concrete have been performed on a regular basis since 1996. The stainless steel measurement points were protected with a threaded cover (Figure 13 and Figure 14). The measurement length of the mechanical strain gauge is 200 mm. Measurements are performed on the CFRP strip at mid-length and strip-end, and at adjacent locations on the concrete. See also Czaderski et al. (2006).

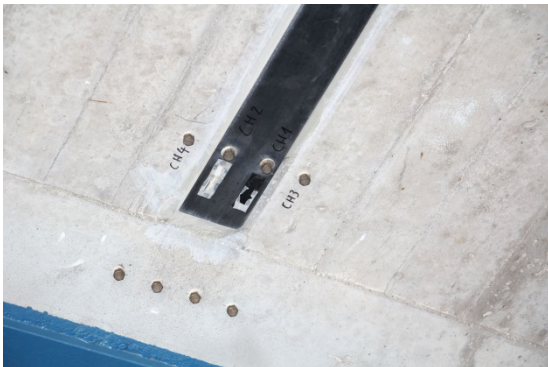
Figure 13: Measurement points at the end of a CFRP strip.

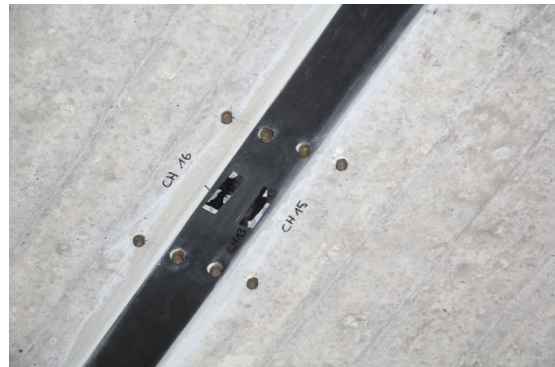
Figure 14: Measurement points at the mid-length of a CFRP strip.
