# The Life Times of Polymer Composites in Construction

**Abstract.** This paper discusses examples that prove the long-term reliability of Fiber Reinforced Polymers (FRP) under extreme loading conditions and outdoor weathering. Results of polymer/steel-composite anchorage systems, Glass Fiber Reinforced Polymer (GFRP) plates and shells, GFRP box girders, Carbon Fiber Reinforced Polymer (CFRP) post-tensioning tendons and CFRP stays are going to be presented.

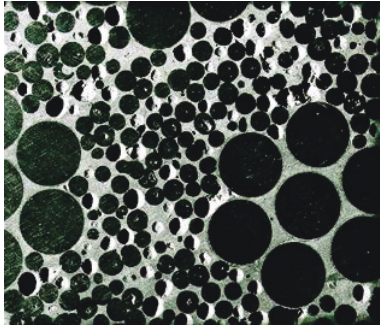
**FIGURE 1.** Cross section of an polymer anchorage system. Large circles are steel wires of 6 mm diameter, the small circles steel balls of about 2 mm diameter. The space in between is cured epoxy resin.

For advanced suspended structures classical metal based cable anchorage systems had to be replaced by polymer based systems to improve the fatigue performance [1, 2]. The steel wires are anchored in a steel cylinder with a conical inner surface, in which the cavities are filled under vibration with epoxy resin, small steel balls and zinc dust (Figure 1), whereupon this filler material is cured by heating.

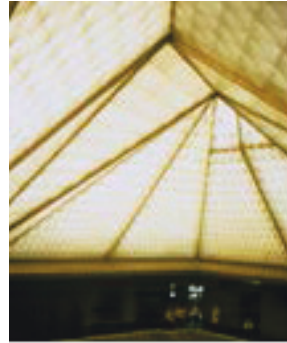
**FIGURE 2a.** Section of the GFRP fold structure roof of the Middle School in Geisslingen in 1967.

Heinz Isler [3] started 1955 with the construction of GFRP domes. All of them showed a high degree of translucency. In 1967 Isler designed and built out of "flat GFRP honeycomb plates" a fold structure with spans of about 20 m based on triangles covering the yard of the Middle School in Geisslingen, Germany (Figure 2a). A great

This pioneering GFRP shells and plates are – except for the example in Figure 2a - still in use. They survived high wind loads, UV-radiation and small amplitude fatigue cycling like in the case of a hydraulic power plant. Due to UV attack there is after more than forty years some degradation of the gelcoat surface, however not of the structural reliability. After such a long time the surface should be repainted with a UV resistant translucent paint. In some cases this has already been done with relative little effort. For the roof of the Middle School in Geisslingen (Figure 2a) it was too late. It had to be replaced in 2014 due to loss of translucence (Figure 2b). From a structural, water- and windproof point of view it was still fully satisfactory. The replacement is a one-to-one copy of the original roof.

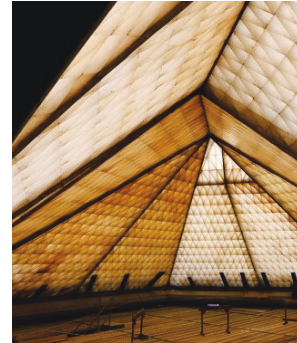
**FIGURE 2b.** Section of the same roof as in Figure 2a in 2014. Replacement due to loss of translucence with a one-to-one copy of the original roof.

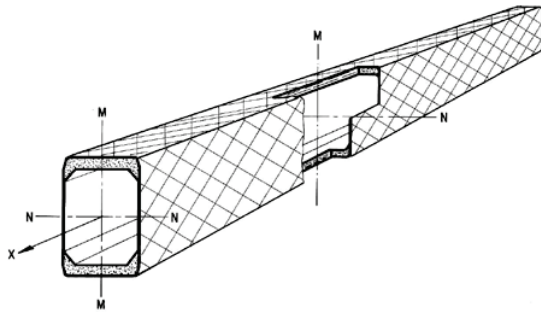
**FIGURE 3.** Perspective view of GFRP box girder.

The construction of the box girders with a length of 3.00 meters is shown in Figures 3 and 4. The flanges are fabricated of unidirectional profiles, and the webs of filament-wound laminates. E-glass rovings were employed as reinforcement fibers and epoxy resin as matrix [4]. The span of all girders was 2.80 m in loading experiments.

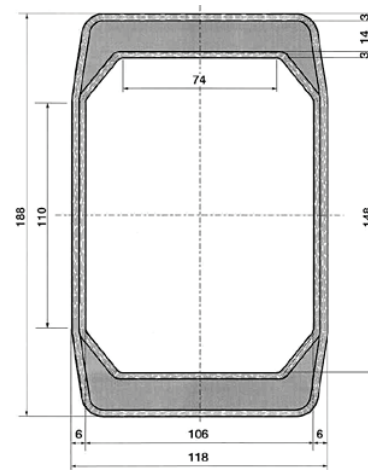
**FIGURE 4.** Typical cross section of the GFRP box girder.

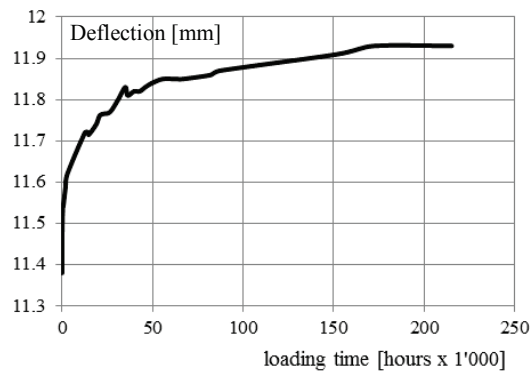
**FIGURE 5.** Creep behavior of girder No. 6 for a constant loading of  $F = 60$  kN in each loading point during 25 years.

After completion of 100 million fatigue cycles with  $F_{\max} = 60$  kN the girder No. 6 was subjected to an extreme long-term creep test. The loading arrangement was (and is even now, since the experiment is still going on) also four-point bending, similar to the monotonous static and the fatigue loading. The load  $F = 60$  kN = constant was accomplished (30% of ultimate load) with a dead load (lead ingot) arrangement. During the first 20,000 hours there were relative high creep rates, as shown in Figure 5.

Now after more than 25 years of constant loading these creep rates are diminishing to zero (Figure 5). The deflections given in Figure 5 have been measured in the center of the girder in the region of the constant bending

moment over a gauge length of 1000 mm. These deflections can be correlated with the curvature of the girder. The first 11.4 mm of deflections at “zero time” have been contributed by the elastic deformation during loading.

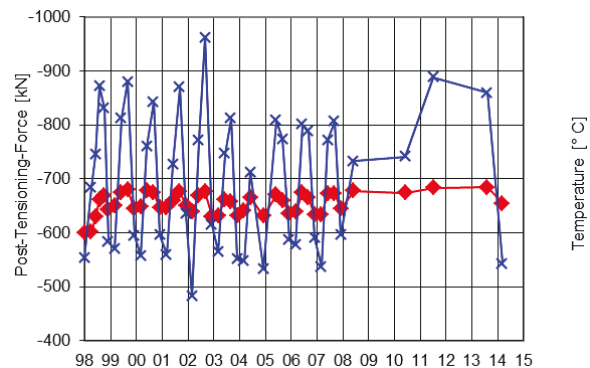
**FIGURE 6.** Post-tensioning-cable-force (red diamond) and temperature (blue x) versus time (17 years) for anchorage #6. There is no stress relaxation with CFRP cables. Since 2008 the intervals of measurements have been reduced.

The cable load (Figure 6) in function of the time has been measured. This project was as far most interesting as in this case the nominal post-tensioning stress in the cable cross sections is as high as 1610 MPa. More similar pilot projects have been presented in [5, 6].

Parallel with the seasonal temperature fluctuation there is a fluctuation of the cable force (Figure 6). The coefficient of thermal expansion for the CFRP tendons is about zero. In summertime, when the temperature is high, the concrete of the bridge girder expands. Due to that the CFRP cable force is increasing. In winter it is opposite.

Most remarkable is that the average of the cable force is a “horizontal straight line”. That means there is no stress relaxation. This is surprising and unexpected from a “steel cable point of view”, but “no stress relaxation” is a typical property of the carbon fibers. The Verdasio Bridge is one of the best proofs for the outstanding long term performance of highly loaded CFRP tendons.

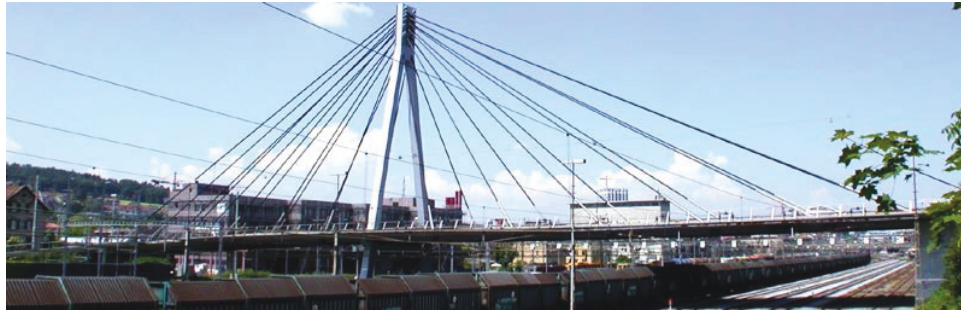
**FIGURE 7.** Stork Bridge in Winterthur, Switzerland with CFRP stay cables.

The Stork Bridge, erected in 1996, is situated over the 18 tracks of the railroad station in Winterthur. The CFRP cable type used for the Stork Bridge consists of 241 wires each with a diameter of 5 mm. This cable type was subjected to a load three times greater than the permissible load of the bridge for more than 10 million load cycles. Not any damage was detected. The CFRP cables with their anchorage heads have been equipped by the Empa with conventional sensors and also with state-of-the-art glass fiber optical sensors which provide permanent monitoring to detect any stress and deformation. Since 1996 the CFRP cables of the stork bridge are fully matching all the high expectations [6].
